STAFF REPORT

PROCEEDING NO. 20I-0437E

IN THE MATTER OF THE INVESTIGATION INTO THE HISTORY AND CONTINUING OPERATIONS OF THE PUBLIC SERVICE COMPANY OF COLORADO COMANCHE UNIT 3 GENERATING STATION PURSUANT TO DECISION NO. C20-0505.

March 1, 2021

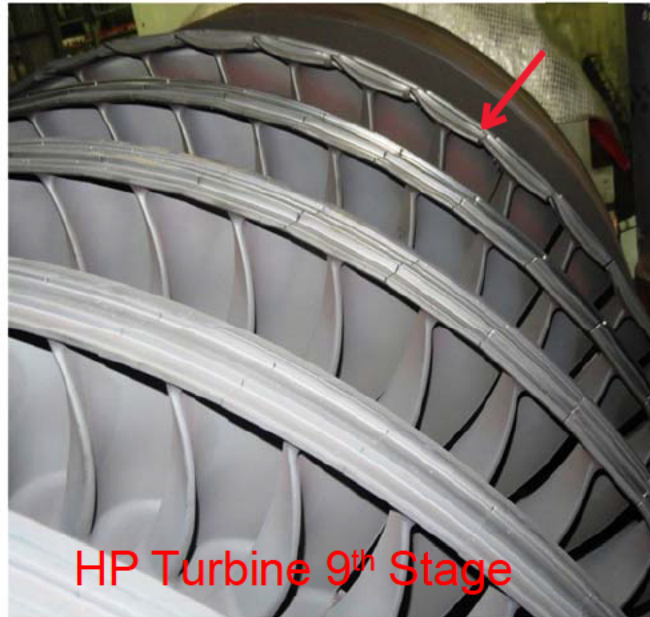
The detailed inspection and analysis of the condition of the turbine suggested that the high pressure turbine shaft and turbine casing was bowed from water induction into the turbine during two events in January and September of 2018. It's likely that damage occurred when the bowed shaft was rotated on the turning gear and during unit startup. Damage also likely occurred during a third event in December of 2018, a startup with excessive vibration from high eccentricity.¹⁰ An example of the damage is shown in the figure below.¹¹

Figure 5. HP turbine damage at 9th stage.

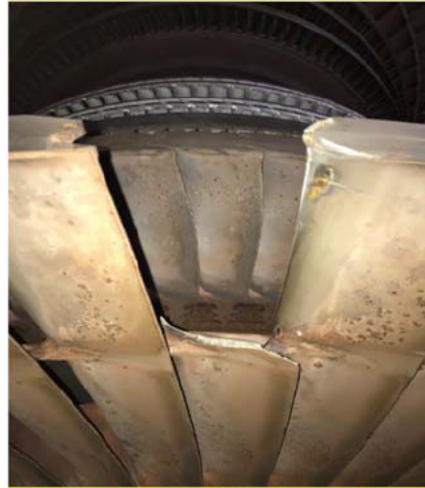
The Company also engaged the services of Structural Integrity Associates (SI) to investigate the mechanism and root cause of the L-1 turbine blade failure shown in Figure 5 below, and to assess the steam cycle chemistry for Comanche 3.¹⁹

Figure 6. Missing turbine blade of L-1 section of LH.²⁰

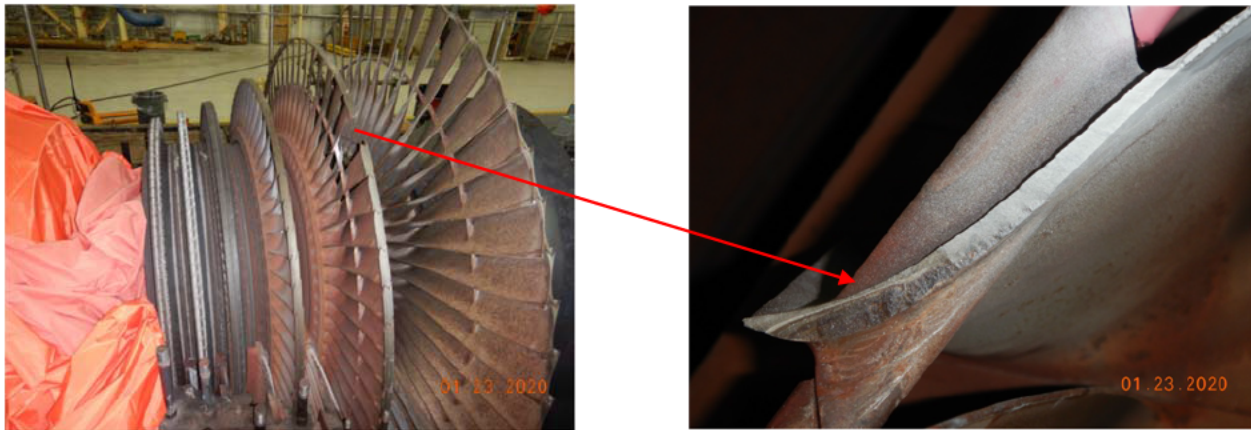
The company also engaged a consultant to assess whether steam cycle chemistry contributed to the blade damage show in the figures below.²¹

Figure 7. Blade damage.

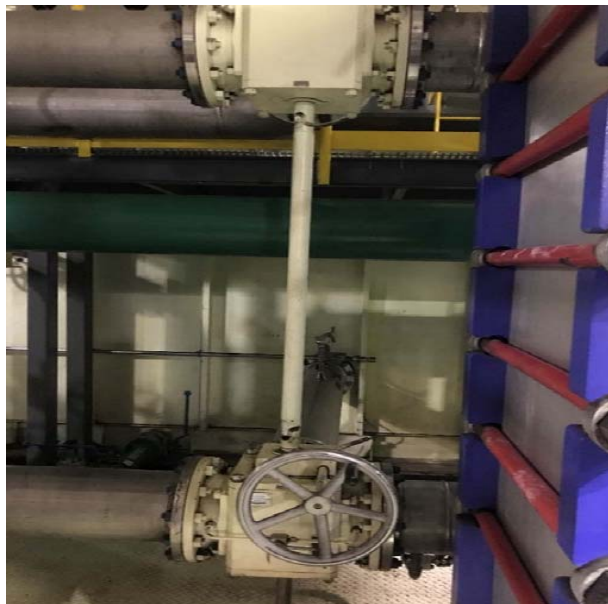
It was noted that the original piping TLO piping design, with a single transfer valve, is contrary to recommended best design practices which recommends that design “[e]nsure the emergency lube oil system configuration is inherently resilient and that no single failure can result in a loss of equipment lubrication. Ensure the emergency oil bypasses coolers and filters and feeds the bearings directly.”³⁶

*Figure 10. TLO cooler 6-way transfer valve.*³⁷

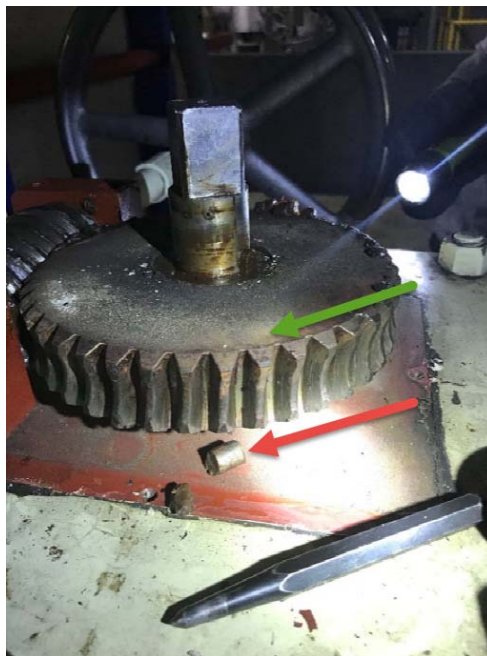
The Technical Improvement Team evaluated the TLO Cooler 6-way Transfer Valve and identified equipment damage based on design flaws in the valve's actuator. Specifically, the design for the valve master actuator worm gear stop pin (dowel pin) was determined inadequate (i.e., the original carbon steel material and 10mm pin size was undersized) and, as a result, sheared off at some unknown point in time during prior operation.³⁹

Figure 11. Stop pin (red arrow) found under gear (green arrow).⁴⁰

Because the stop pin was sheared, the actuator was able to rotate the valve's in-stream element (i.e., ball or plug) to a position which eliminated all TLO flow to the turbine bearings. To inspect or repair stop pin, the valve actuator

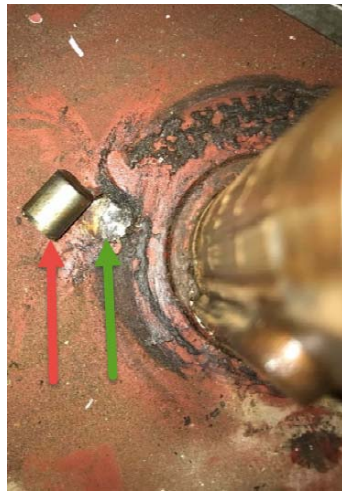
must be disassembled as this stop pin is located underneath actuator gear. Because of location of the pin below the gear, the valve would have to be out of service (i.e. under lockout tag out control) to inspect and repair the pin. The valve could only be out of service if the turbine lube oil system was out of service. Upon disassembly of the valve, the sheared stop pin was discovered laying loose under the gear. Figure 10(a) shows the broken stop pin (red arrow) and the sheared off section of stop pin (green arrow) in the valve body. Figure 10(b) shows the underside of the gear shows circular collar (green) with a 180-degree collar section (red) which butts against the stop pin to prevent over-travel.

Figure 12 (a) Gear removed.⁴¹

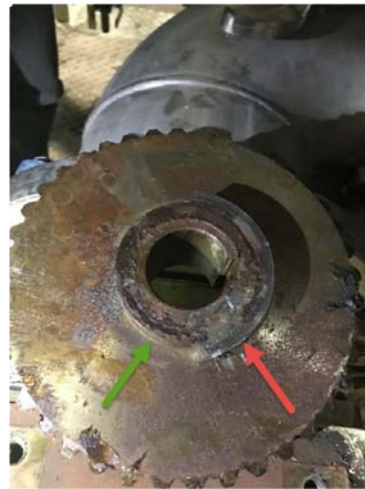
Figure 10(b) Underside of gear.⁴²

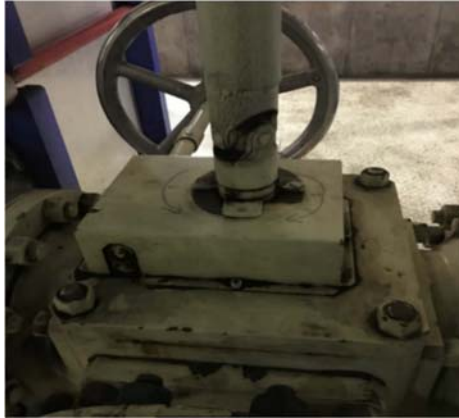
- *TLO Cooler 6-Way Valve Master Valve Actuator Design.* The master actuator did not have adequate visual indication of the relative position of its in-stream element as shown below.

Figure 13. Sharpie inscribed 6-way transfer valve position indication as found.⁴³

The Technical Improvement Team corrected the inadequate visual indication position on the valve actuator by replacing the existing square shroud, with a rounded “nub” indicator and no signage, with a circular plat and “notched” indicator with plastic labeling as show below.

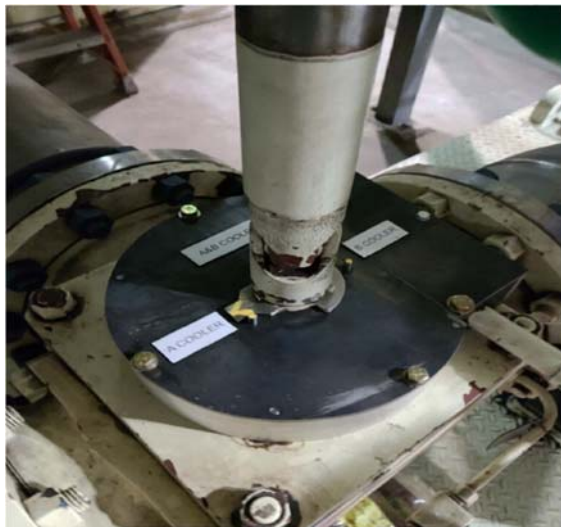
Figure 14. 6-way valve position indicator as modified.

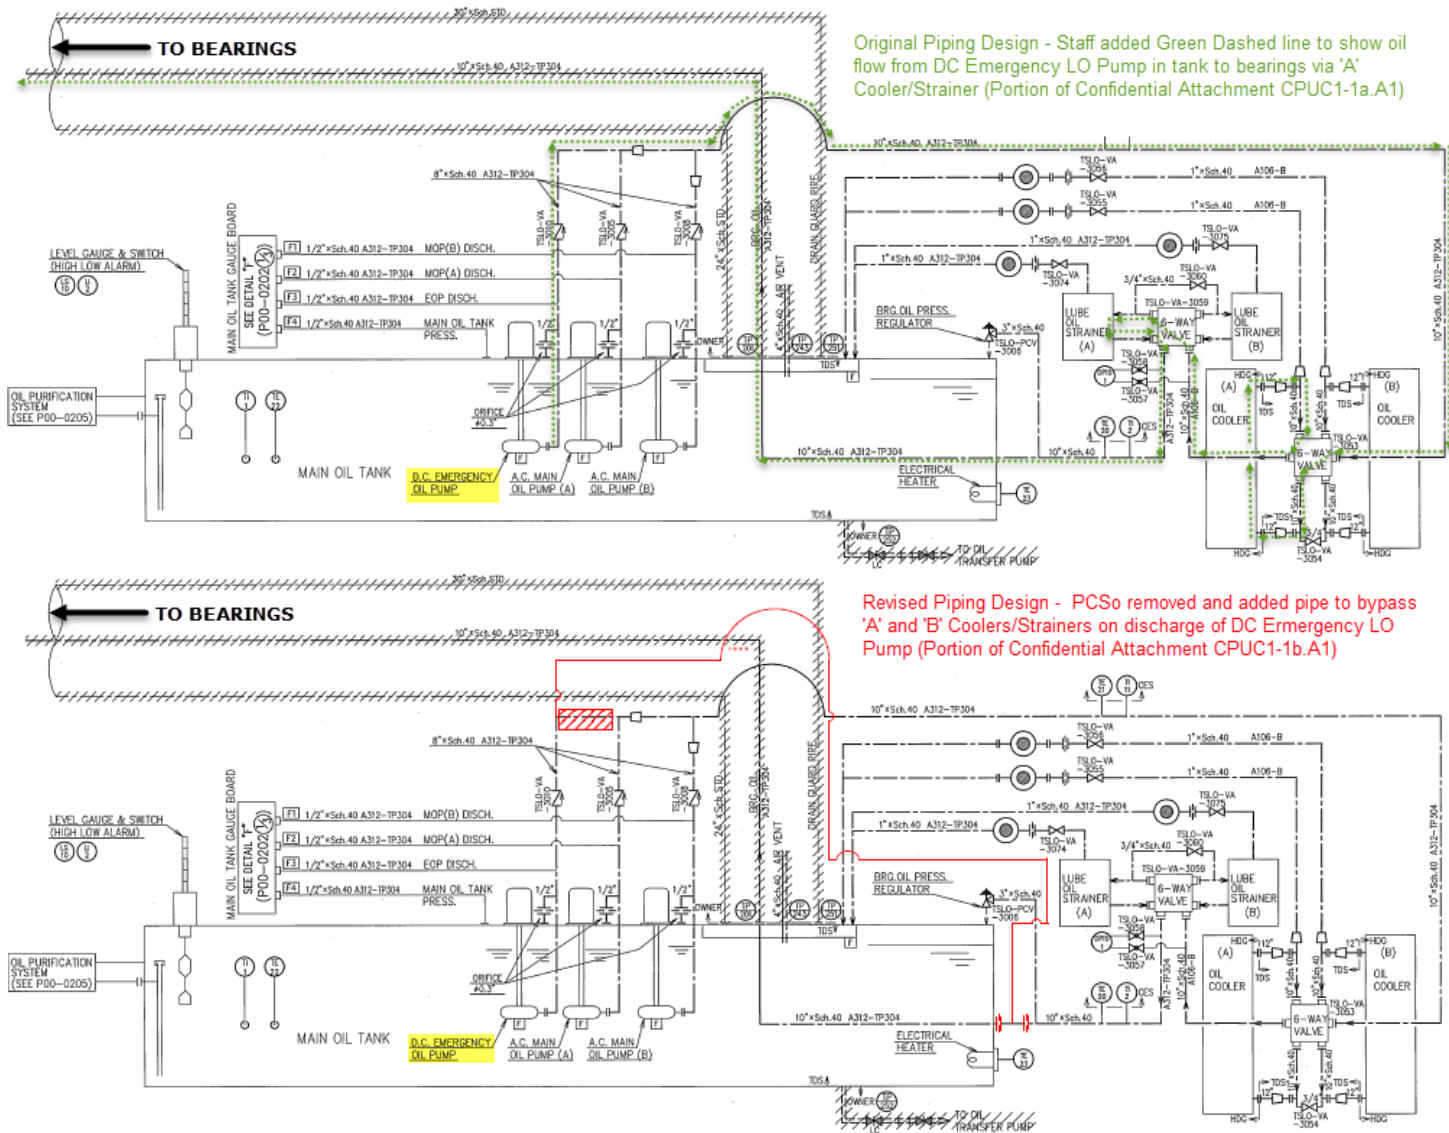
- *TLO Cooler TLO Backup Source.* The TLO Cooler 6-Way Valve was the single point of failure for the June 2, 2020 incident. When the valve stop pin failed, it allowed plant personnel to position valve such that it isolated TLO flow to critical turbine components and also isolated TLO flow from the emergency backup TLO pump.

Figure 15. Original P&ID of lube oil system (top) vs. revised P&ID (bottom).

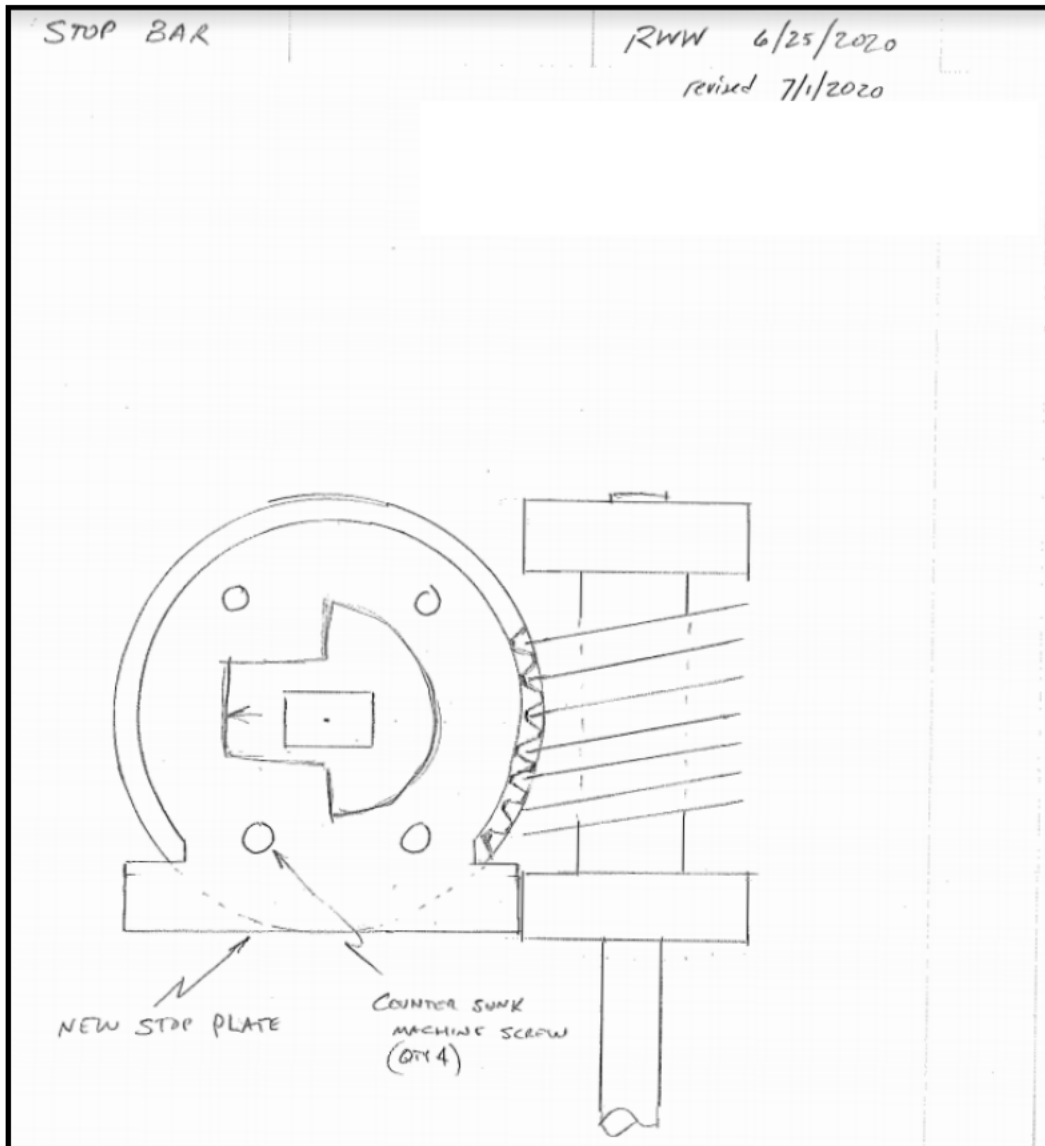
Figure 16. Valve sketch (1 of 2).

It was noted that the drawings were created and signed by the Technical Improvement Team Lead, who also happens to be the Plant's Manager of Reliability. There was no secondary or independent signature that demonstrated that the design was reviewed or verified. As is apparent by the single signature, design changes appear to have been made also without independent verification. There was no indication of the materials used for the modifications to the valve. There is no discussion of why modifications were made necessary (e.g. the result of a previous incident or identified by a SPOF analysis). There is no indication of what service standard was used, nor was there any indication that the drawings were filed or input into the plant's drawing system for future reference or traceability.

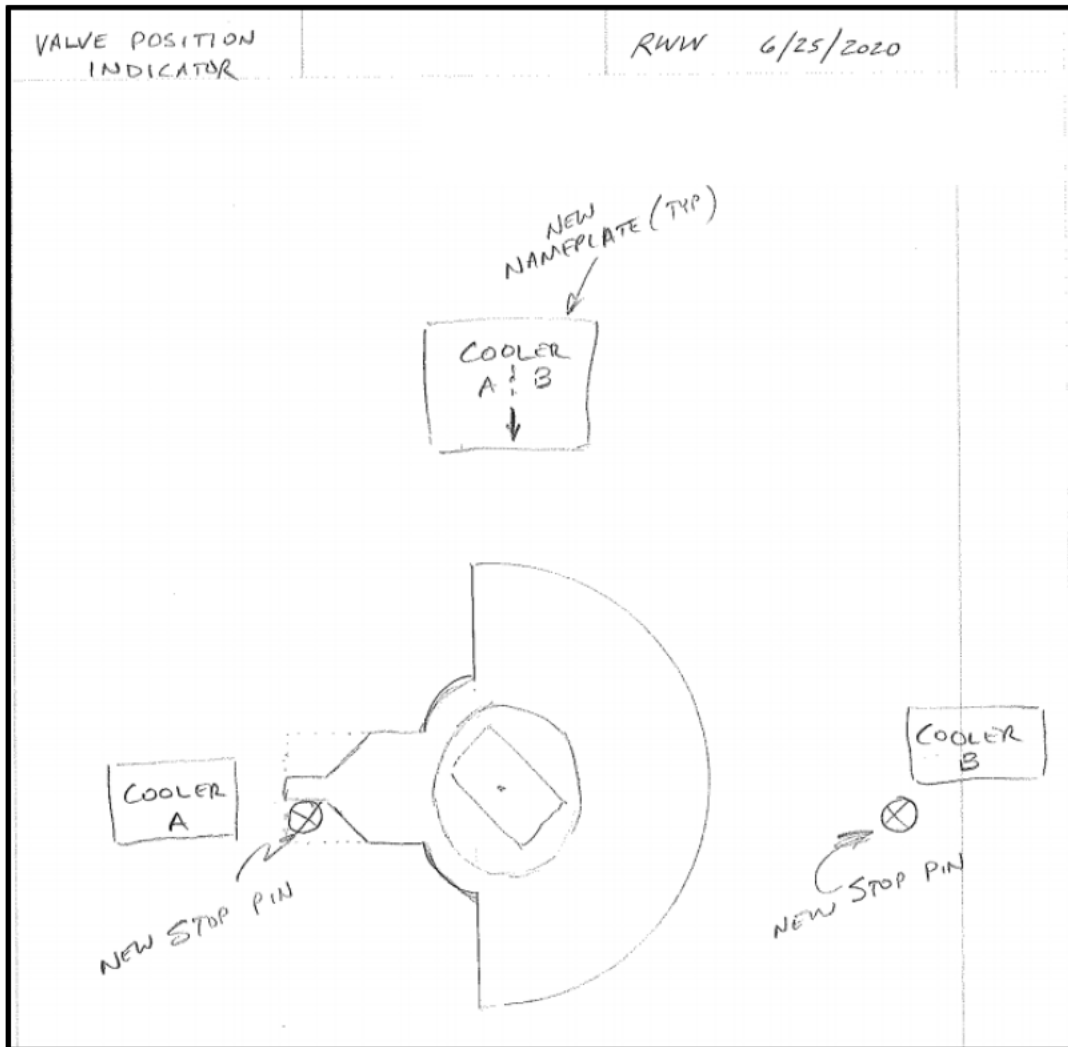
Figure 17. Valve sketch (2 of 2).

While this is may be a minor design change, it is essential to create a record of what modifications were made and why.
